## MATERIALS INVESTIGATION OF FAILED PLASTIC ANKLE-FOOT ORTHOSES

E. P. Lautenschlager<sup>1</sup>, S. C. Bayne<sup>1</sup>, R. Wildes<sup>1</sup>,  
J. C. Russ<sup>2</sup>, and M. J. Yanke<sup>2</sup>

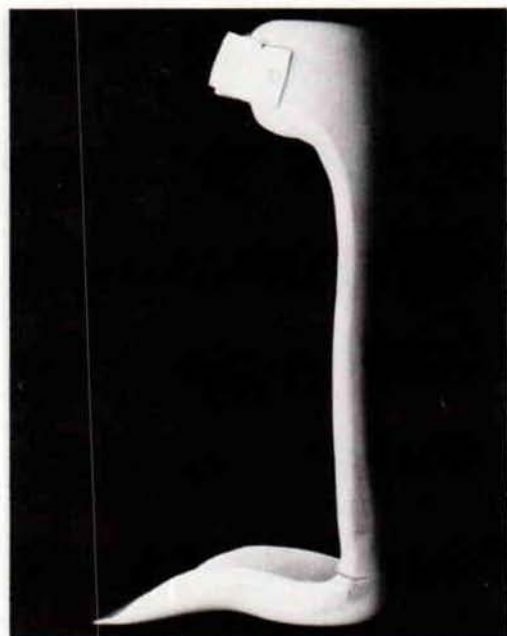
In April 1974 the Department of Biological Materials received for analysis the Ortholen ankle-foot orthosis (AFO) that had failed as shown in Figure 1. This device was one of two worn bilaterally by an active man who weighed 175 lb., and was 5 ft. 11 in. tall. The failure began as a small crack at the base of the right angle, and then propagated slowly for several months until the integrity of the device became questionable.

Fig. 1. Failed ankle-foot orthosis.

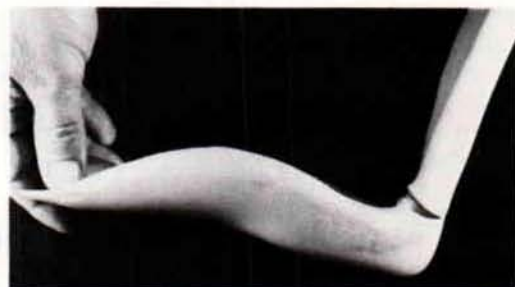
Figure 2 shows that downward loading near the ball of the foot places the right-angled area in a state of tension and opens up the crack.

Fig. 2. Tensile loading opens up crack.

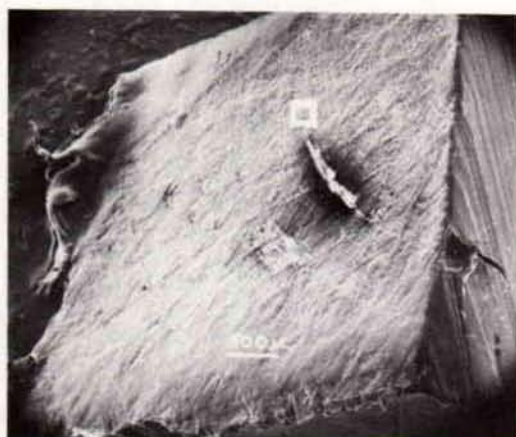
Fig. 3. Low magnification SEM of fracture surface. Area in white square presented in Figure 4.

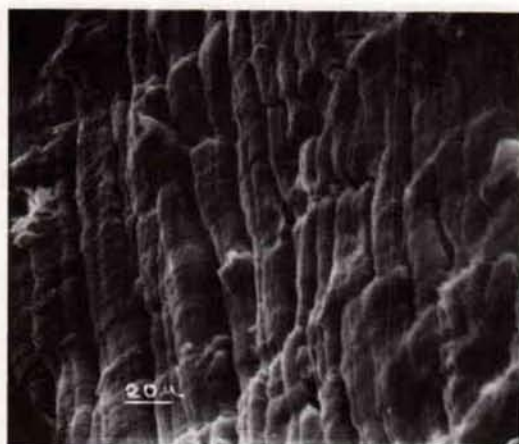
Because tension opened the crack and the propagation was reported to be slow, fatigue was suspected as the mode of failure. Fatigue can occur with cyclic loads which are well below the ultimate or maximum load-bearing characteristics of the material. Because fatigue progresses in a step-wise fashion with a crack that is opened up a small additional amount during every cycle, it can be detected from a fracture surface characterized by small steps or striations. This is the case as shown in Figure 4 for the SEM of the fracture surface of the AFO supplied.

Fig. 4. High magnification SEM of fracture surface. Note the fatigue striations.

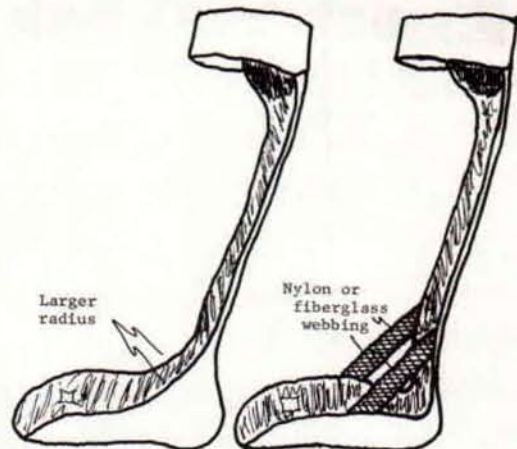
Fig. 6. Two methods of reducing the high tensile stress concentration at the AFO right-angled bend.

Although one might consider utilizing a stronger material, the basic change should result in a reduction of the high stress concentration produced by the sharp right-angle bend (i.e., the fracture site).

Reduction in stress at the radial edges could be provided by a larger radius, as shown in Figure 6, *left*, but this would change the resistance to both dorsiflexion and plantar flexion. However, failure occurs by fatigue, which is primarily a tensile phenomenon (plantar flexion). Therefore, when an orthosis is required to resist only plantar flexion (high tensile forces), and need not necessarily rigidly counteract compression forces, an orthosis of the type shown in Figure 6, *right*, would suffice. Here a webbing strap provides the resistance to tension during plantar flexion but folds or collapses during compression, thus preventing fatigue failure.
