## MATERIALS INVESTIGATION OF FAILED PLASTIC ANKLE-FOOT ORTHOSES

E. P. Lautenschlager<sup>1</sup>, S. C. Bayne<sup>1</sup>, R. Wildes<sup>1</sup>,  
J. C. Russ<sup>2</sup>, and M. J. Yanke<sup>2</sup>

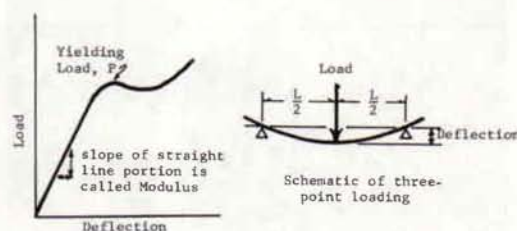
$\Delta P/\Delta y$  = change of load per change of deflection in straight line elastic region of curves as shown in Figure 5,

Fig. 5. Typical deformation curve obtained in three-point bending.
